SAFE PRACTICES *in Patient Care*

Misconnections between medical devices with Luer connectors: *under-recognized but potentially fatal events in clinical practice*

Preventing tubing misconnections: a practical view

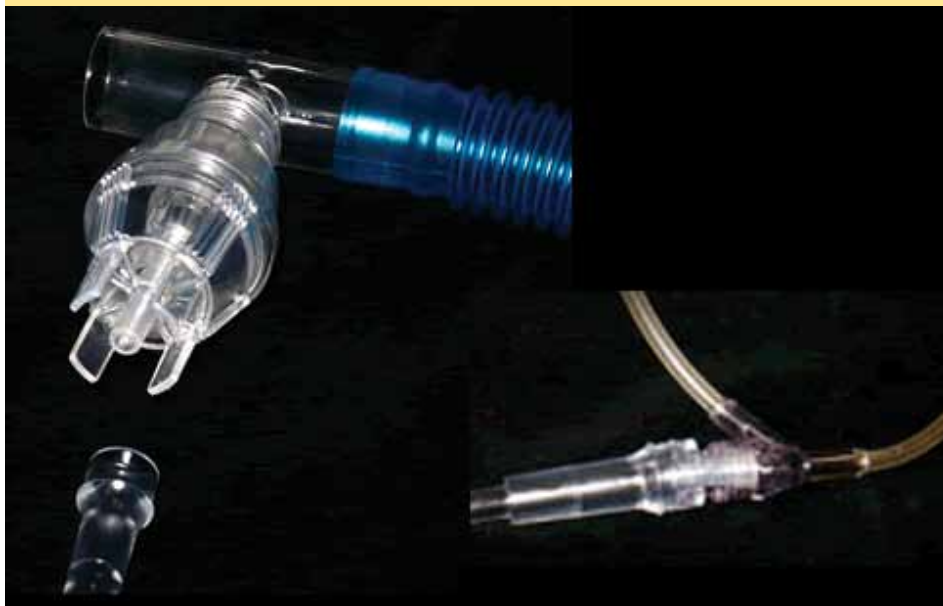
Tubing Misconnections

Tube delivering oxygen fell off nebulizer

The oxygen tubing was connected to a Needleless Access System IV tubing Y-site
